National Inspection Services  
# : 179219 on 01/17/2020  
VIN: 1S12E9530DE526780 Unit: 13108

## 2013 STRICK DRY VAN TRAILER

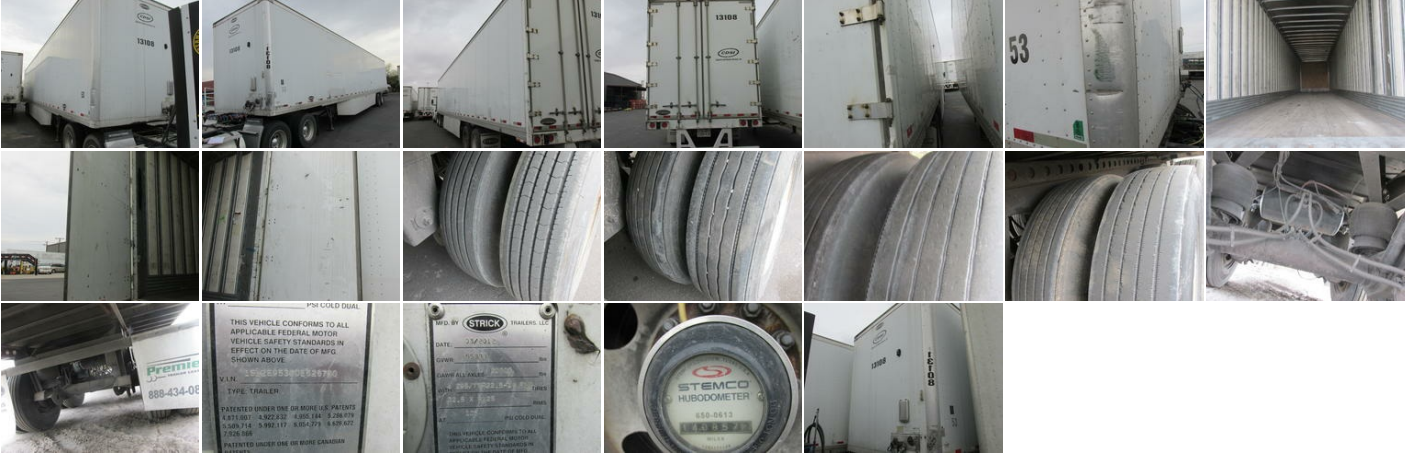
Wear and Tear Items	
FRONT	RIGHT CORNER POSTED DENTED AT BOTTOM, SMALL DINGS AT LEFT POST
LEFT SIDE	SCRATCHES / LINEAR DENTS, PEELED AREA AND WALL PANEL PATCH
REAR	PAINT STARTING TO FLAKE BELOW DOOR
INTERIOR	2 SECTIONS OF LINER MISSING AT RIGHT WALL
TIRES	2 MEASURE BELOW 10/32
