National Inspection Services
: 179217 on 01/17/2020
VIN: 1S12E9533DE526806 Unit: 13114

2013 STRICK DRY VAN TRAILER

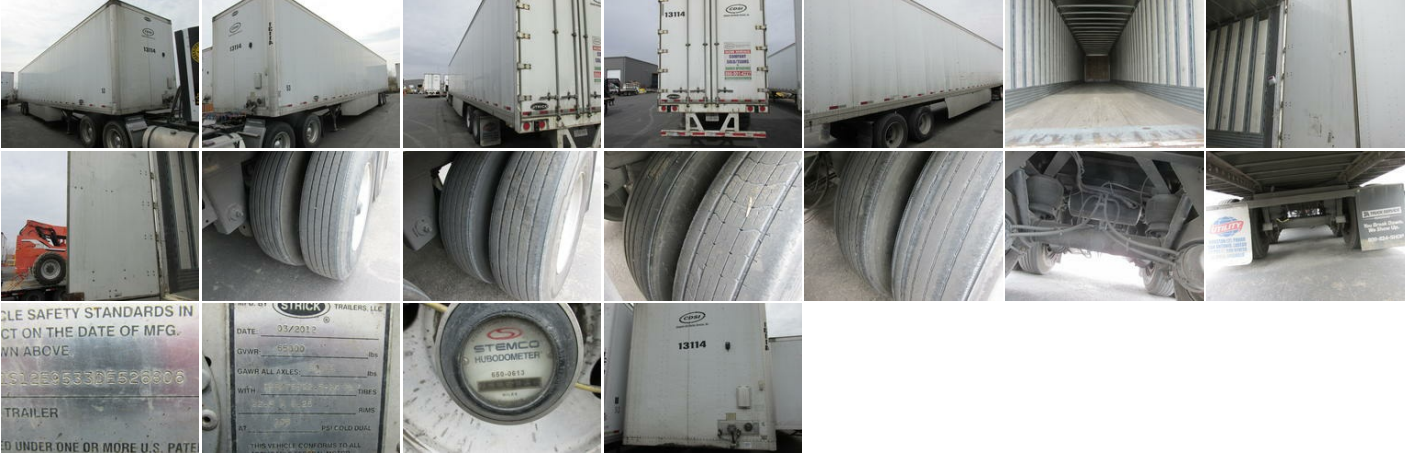
Wear and Tear Items	
FRONT	RIGHT CORNER POST DENTED AT BOTTOM, SMALL DINGS AND SCRATCH AT LEFT POST
REAR	PAINT STARTING TO FLAKE BELOW DOOR
RIGHT SIDE	CHIPPED / SCRATCHED
TIRES	A FEW WORN, 3 MEASURE BELOW 10/32
