National Inspection Services  
# : 179215 on 01/17/2020  
VIN: 1S12E9534DE526765 Unit: 13115

## 2013 STRICK DRY VAN TRAILER

### Inspection Photos

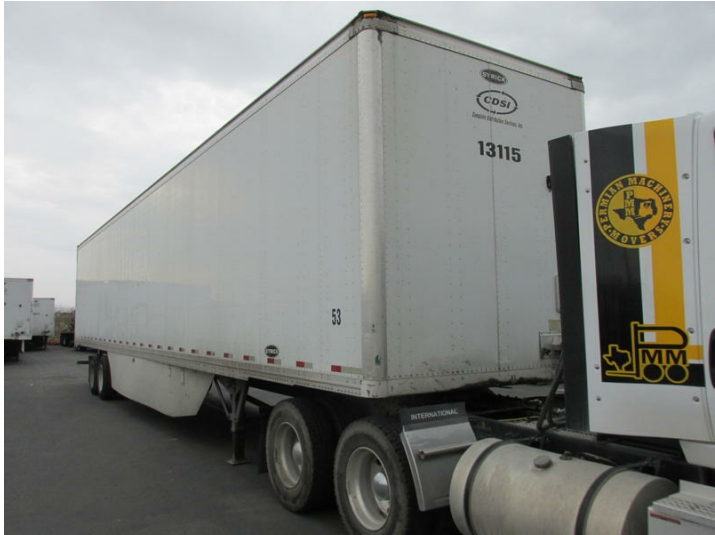
Notes / Description
HUB READING = 181983

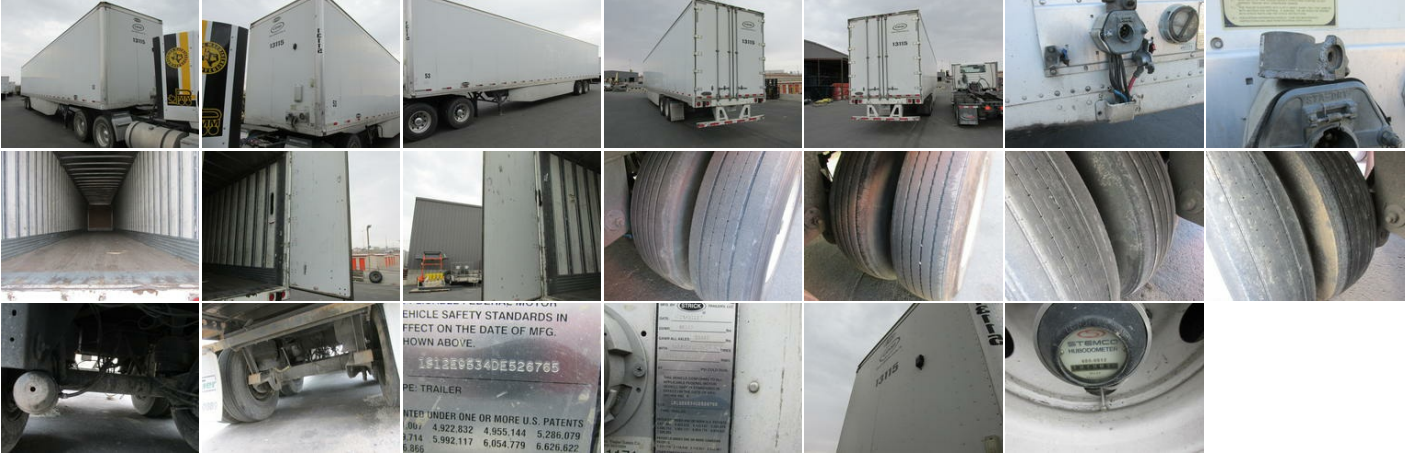
## 2013 STRICK DRY VAN TRAILER PHOTOS

Wear and Tear Items	
TRACTOR HOOKUPS	BROKEN BLUE LINE COUPLER AND MISSING ELECTRICAL COVER - BRAKES LOCKED
FRONT	SMALL DENTS AT LOWER LEFT CORNER
BUMPER	SLIGHTLY BENT UPWARD AT RIGHT SIDE
REAR	PAINT STARTING TO FLAKE BELOW DOOR
TIRES	WORN, 7 MEASURE BELOW 10/32
