National Inspection Services  
# : 179211 on 01/17/2020  
VIN: 1S12E9539DE526762 Unit: 13123

## 2013 STRICK DRY VAN TRAILER

### Inspection Photos

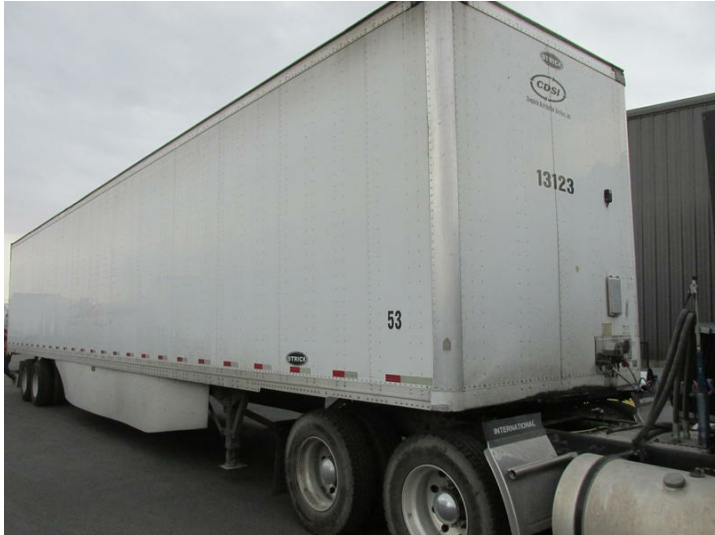
HUB READING=090685,

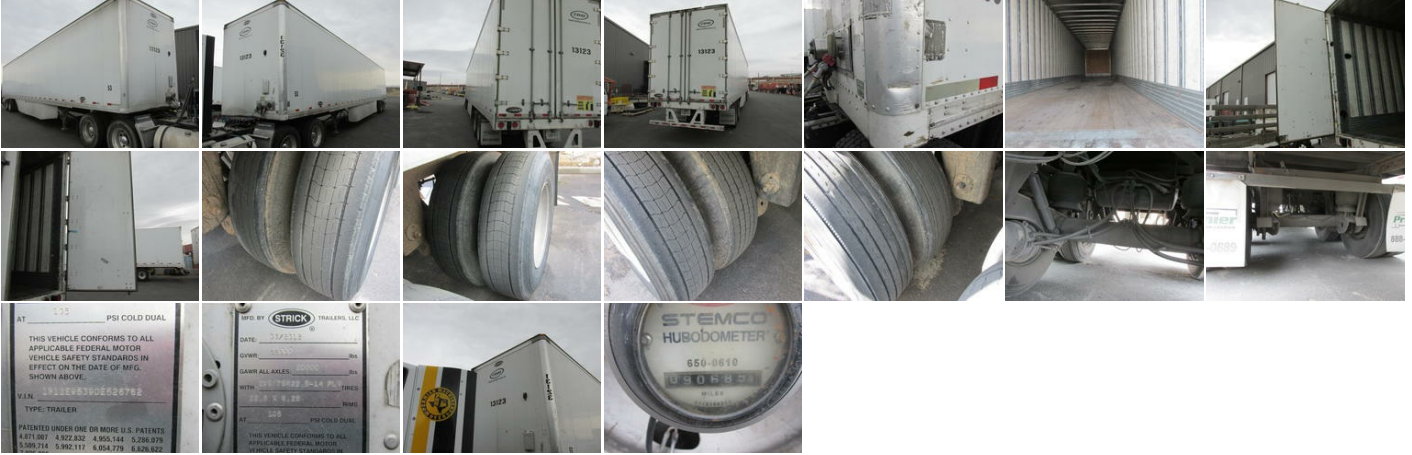
## 2013 STRICK DRY VAN TRAILER PHOTOS

Wear and Tear Items	
FRONT	LEFT CORNER DENTED AND SCRATCHED
REAR	PAINT STARTING TO FLAKE BELOW DOOR
TIRES	SEVERAL WORN, 5 MEASURE BELOW 10/32
